Follow-on Studies Using the Voyager Spacecraft Thermal Model

ICES Paper 2019-377

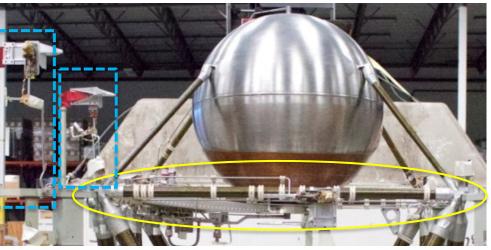
Propulsion Subsystem Thermal Design

- Fuel Tank positioned at center of spacecraft bus.
- Blow-down monopropellant (hydrazine) flows through stainless steel lines, filters and valves to reach each of the 16 thruster/valve assemblies (T/VAs).

- Propellant lines mostly routed in-plane, directly beneath spacecraft bus.
- Four roll thruster lines are the coldest.
- Only 6 temperatures sensors on propulsion subsystem hardware.
- Derived channels used to estimate temperatures near thruster inlets.
